TRIPARTITE 2019 TOKYO

Session 8 Design safety

CONVERSIONS

STELLAR DAISY

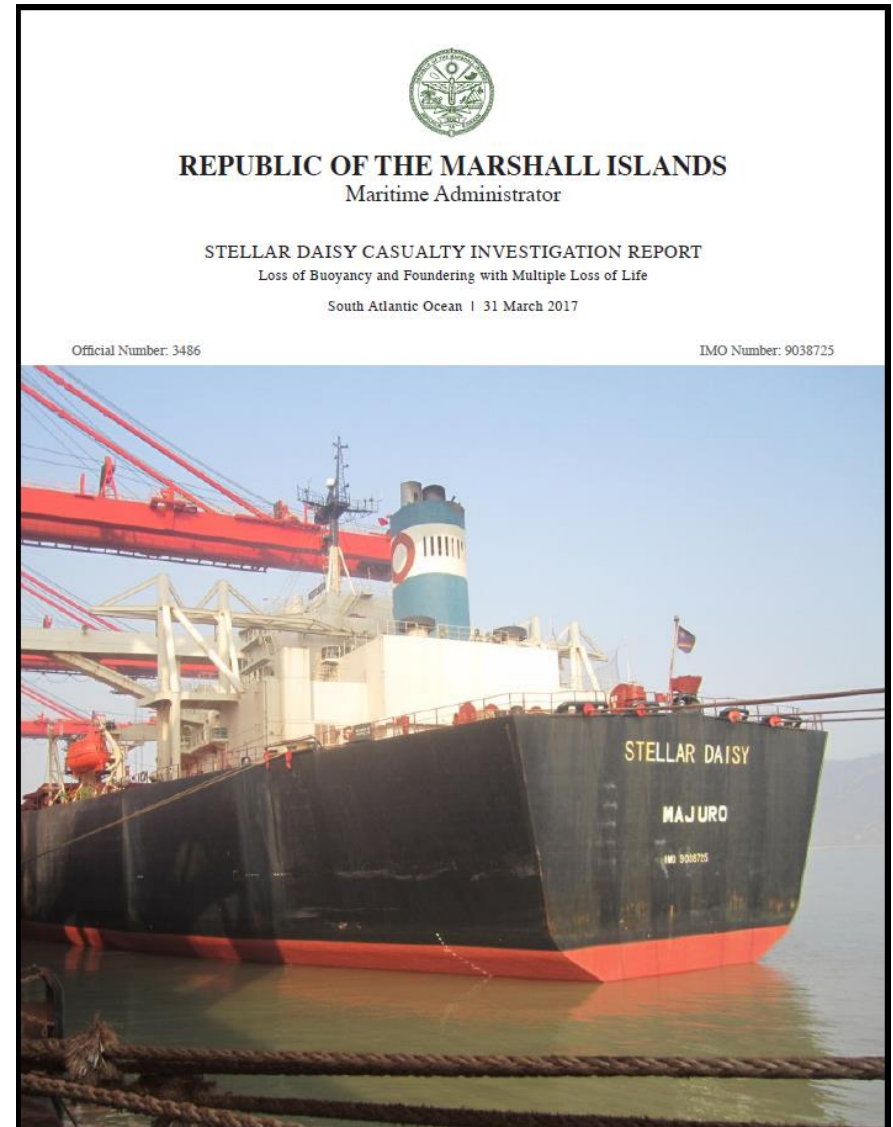
Built as a VLCC 1993 > Converted to VLOC 2009

Change of Class in 2008

Change of Flag > On completion of conversion

Foundered on 31 March 2017, enroute from Brazil to China – 22 lives lost

“Based on the information available, a possible sequence of events leading to the loss of buoyancy and foundering of STELLAR DAISY within approximately five minutes was:

1. structural failures in the No. 2 P WBT and simultaneous, or near simultaneous, structural failures in the No. 3 P WBT resulting in a breach of the bottom plate and very rapid, uncontrolled flooding of both tanks;
2. rapid, progressive structural failures of the transverse structure, collapse of the cross deck between multiple cargo hatches and cracks in the main deck resulting in down flooding of port side wing tanks and cargo holds;
3. failure of longitudinal bulkheads resulting in cargo spilling into the port side wing tanks and flooding of cargo holds adjacent to flooded wing tanks;
4. flooding of the Nos. 5 and 6 P Voids due to failures of the deck and side shell between frames Nos. 48-50; and
5. flooding of the accommodation block.”
