Industry Releasable Threat Bulletin (IRTB) 025 (to IRTA 01 MAR 21)

- 3. Incident.** Likely Limpet Mine discovered attached to vessel at anchor.
- 4. Date/time.** 310700Z Dec 2020
- 5. Location.** Iraqi Territorial Waters, IVO Al Bakr Oil Terminal (293300N / 0484700E)

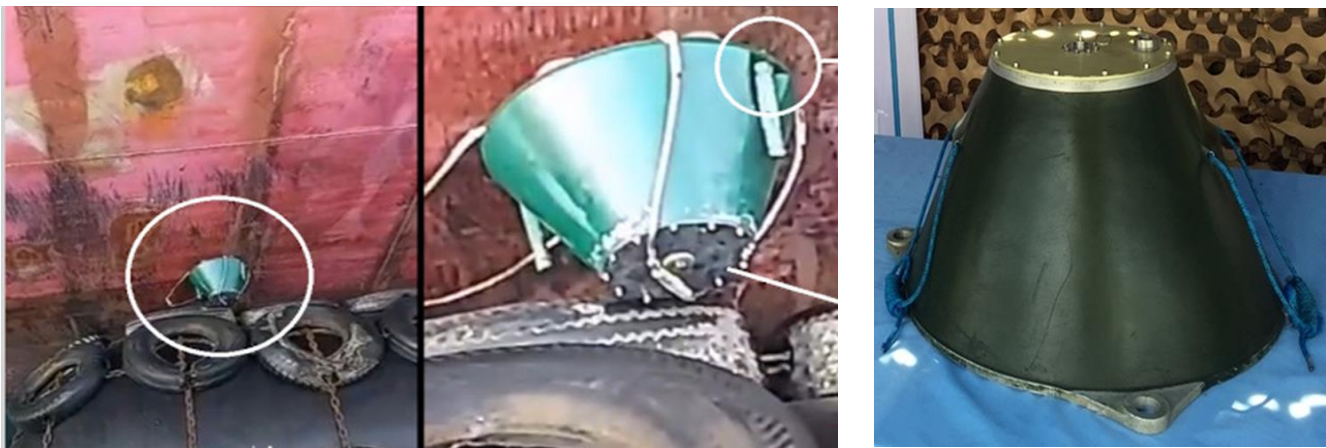
- 6. Incident Description.** On 31 Dec 20 at 0700Z, the Liberian-flagged oil tanker MT POLA was conducting a ship-to-ship transfer with the MT NORDIC FREEDOM when a likely deliberately-placed Limpet Mine was discovered attached to the MT POLA's hull. The MT POLA had been at anchor at the KAZ anchorage, and arrived in the area in the beginning of November, therefore it is unclear at this point when the device was attached. As of 0940Z on 2 Jan the device had been successfully removed by an Iraqi Technical Team, images of the device can be seen below on the left with a likely example device on the right.

8. **Assessment.** Although only a single device has been reported, we cannot discount that further devices have been attached to vessel that were in or are in this anchorage. Due to the STS we are currently unable to assess the depth at or below the water line at which the device was originally attached.

9. **Recommendations.** Vessels at anchor in the Gulf and Gulf of Oman are advised to maintain an enhanced lookout and security posture. If a vessel detects anything unusual attached to the hull, Masters are advised to consider to reduce the crew below waterline to the minimum, evacuate them from the immediate area and mustered in a safe and open place. Any vessel that has used the KAZ anchorage in the recent past, is recommended to check their hull as far as is possible. While these waters are routinely patrolled by CMF and other warships, the timely and comprehensive reporting of incidents and suspicious activity remains crucial to allow for a rapid incident response. We request that, where possible, and without endangering the vessel or crew, vessels obtain and report as much factual detail as possible of incidents and suspicious activity, to include event logs, photographs, video, and radar footage. Vessels are, in any event, requested to remain vigilant and to adhere to BMP5¹ when transiting the Gulf, Gulf of Oman, Gulf of Aden and Southern Red Sea.
